# Extended service life

by **Greg Nixon,**  
**NanoSteel Company US,**  
**USA**

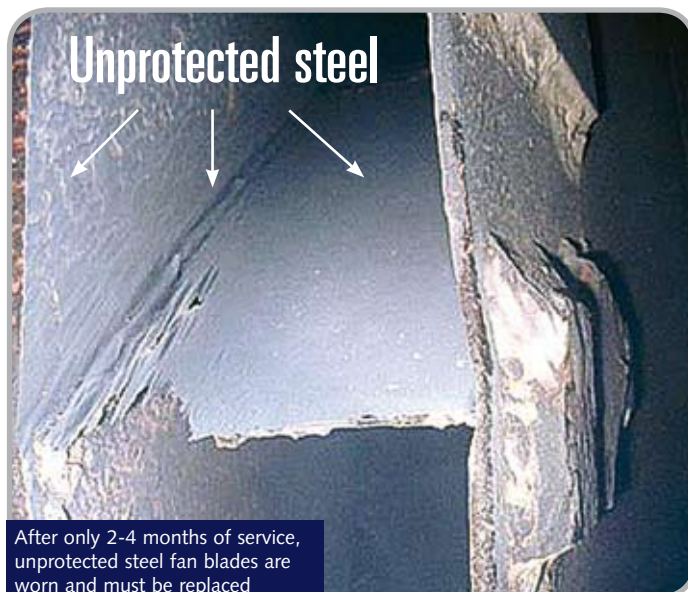
Unprotected drum after six months

After six months of service, unprotected rotary vane feeder drum is damaged by wear and corrosion and must be replaced

Argoss' solution for the rotary vane feeder drum was to weld a 19mm (0.748in) thick NanoSteel overlay wear plate, for resisting wear and moderate impact, in the centre and outer half on the top side of each vane, and then apply a 1mm (0.039in) thick NanoSteel thermal spray coating, for corrosion and wear resistance, to the wear plate surface and remaining vane pocket and drum surfaces.

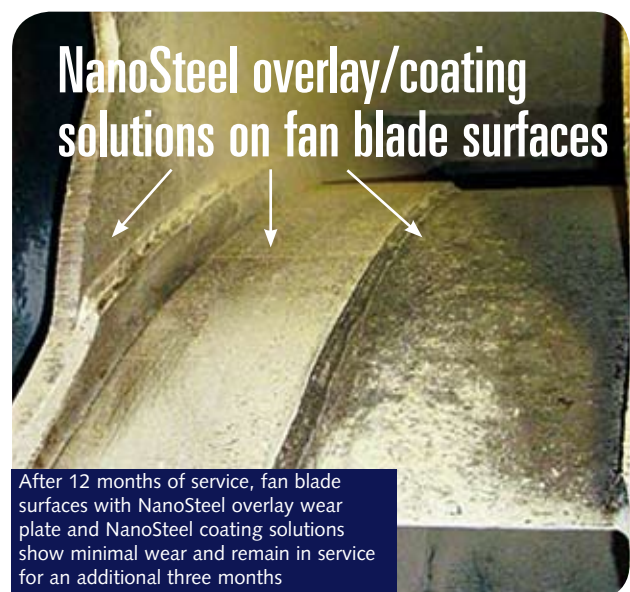
NanoSteel protected drum after 12 months

After 12 months in service, drum with NanoSteel wear plate and coating solutions show minimal wear and no corrosion damage

After 12 months in service, an inspection of the rotary vane feeder drum protected with a NanoSteel overlay wear

plate and thermal spray coating showed minimal surface wear to be 1.5mm (0.059in) and no corrosion damage. This drum remained in service an additional three months before removal for maintenance.
